An Investigation of the Plastic Fracture
of High Strength Steels

NASA Technical Report No. 5

May 1973

(This report was submitted as a dissertation by T. B. Cox in partial fulfillment of the requirements for the degree of Doctor of Philosophy at the Carnegie-Mellon University.)

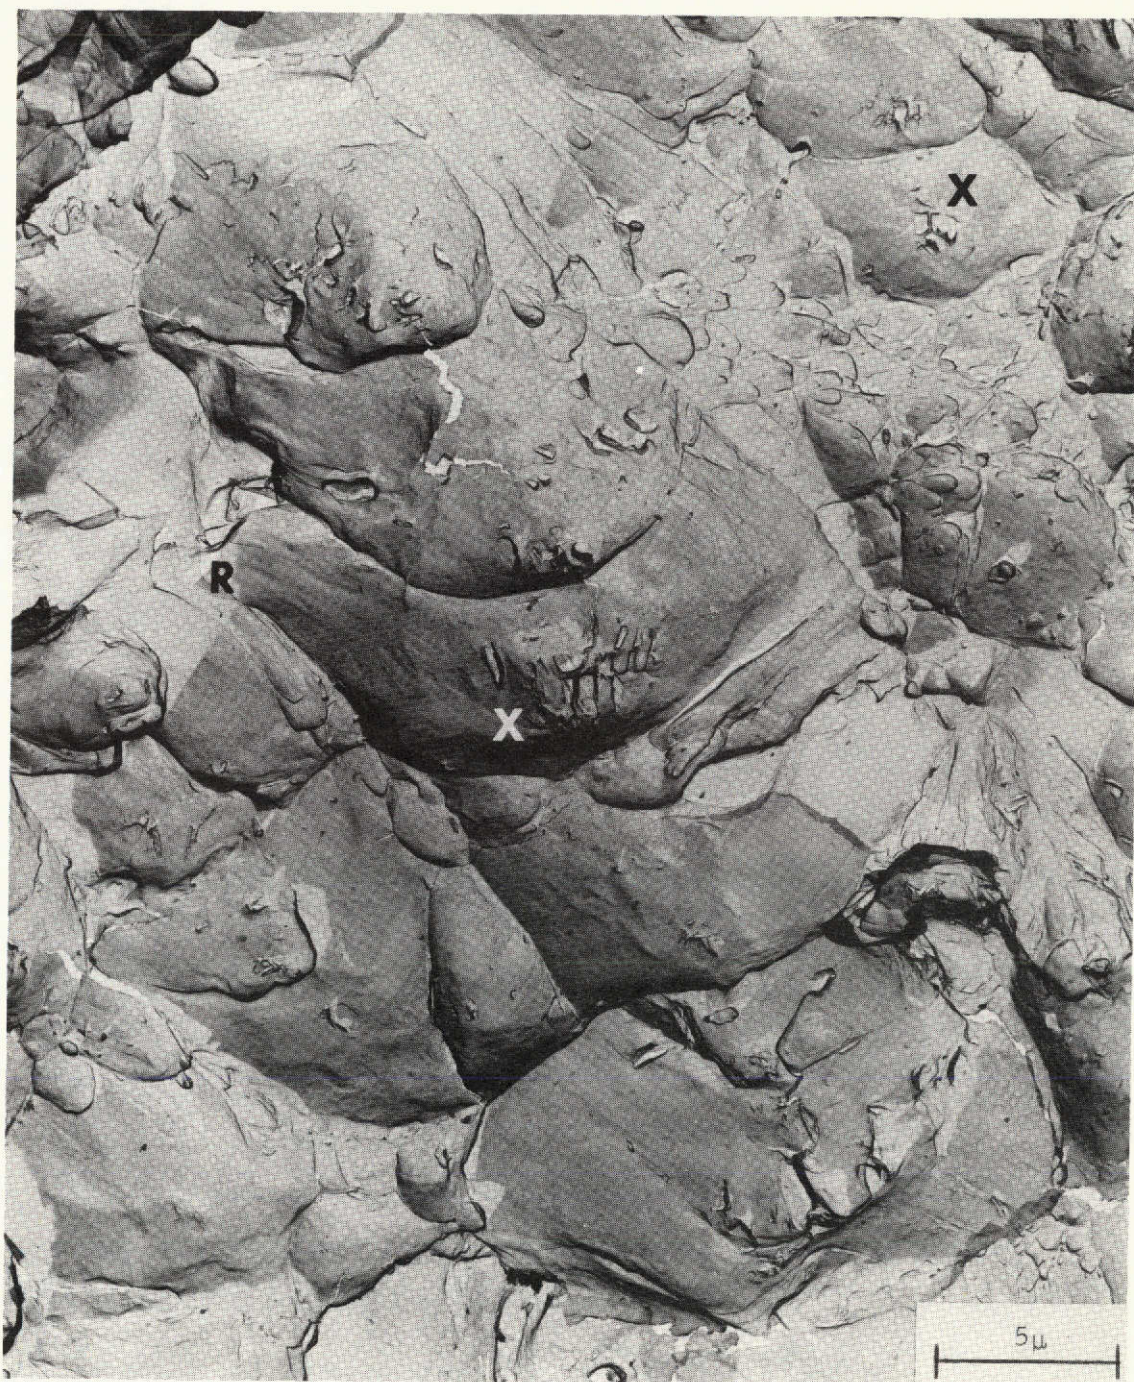
Figure 17 Electron Fractograph From Central Region of Smooth Tensile Fracture in Commercial 18 Ni Maraging Steel. (Carbo-nitrides indicated by X; Deformation markings indicated by R).

Fractographs at higher magnifications than those found in the previous section are presented in Figures 17 and 18 as representative of the fracture surfaces of both 18 maraging steels. Examination of these figures reveals the fracture surfaces to be almost completely covered by large equiaxed dimples approximately 10-20 microns in diameter. At the positions marked "X" on the fractographs, examples of impressions of carbo-nitride particles may be seen at the bottoms of dimples. The particular carbo-nitride marked "Y" in Figure 18 exhibits clearly a cleavage fracture pattern, suggesting that the associated dimple was nucleated by the separation of the halves of the fractured non-metallic inclusion. The observation of cleavage patterns on carbo-nitride particles in the large dimples of the maraging steels was a general observation. It should also be noted that the

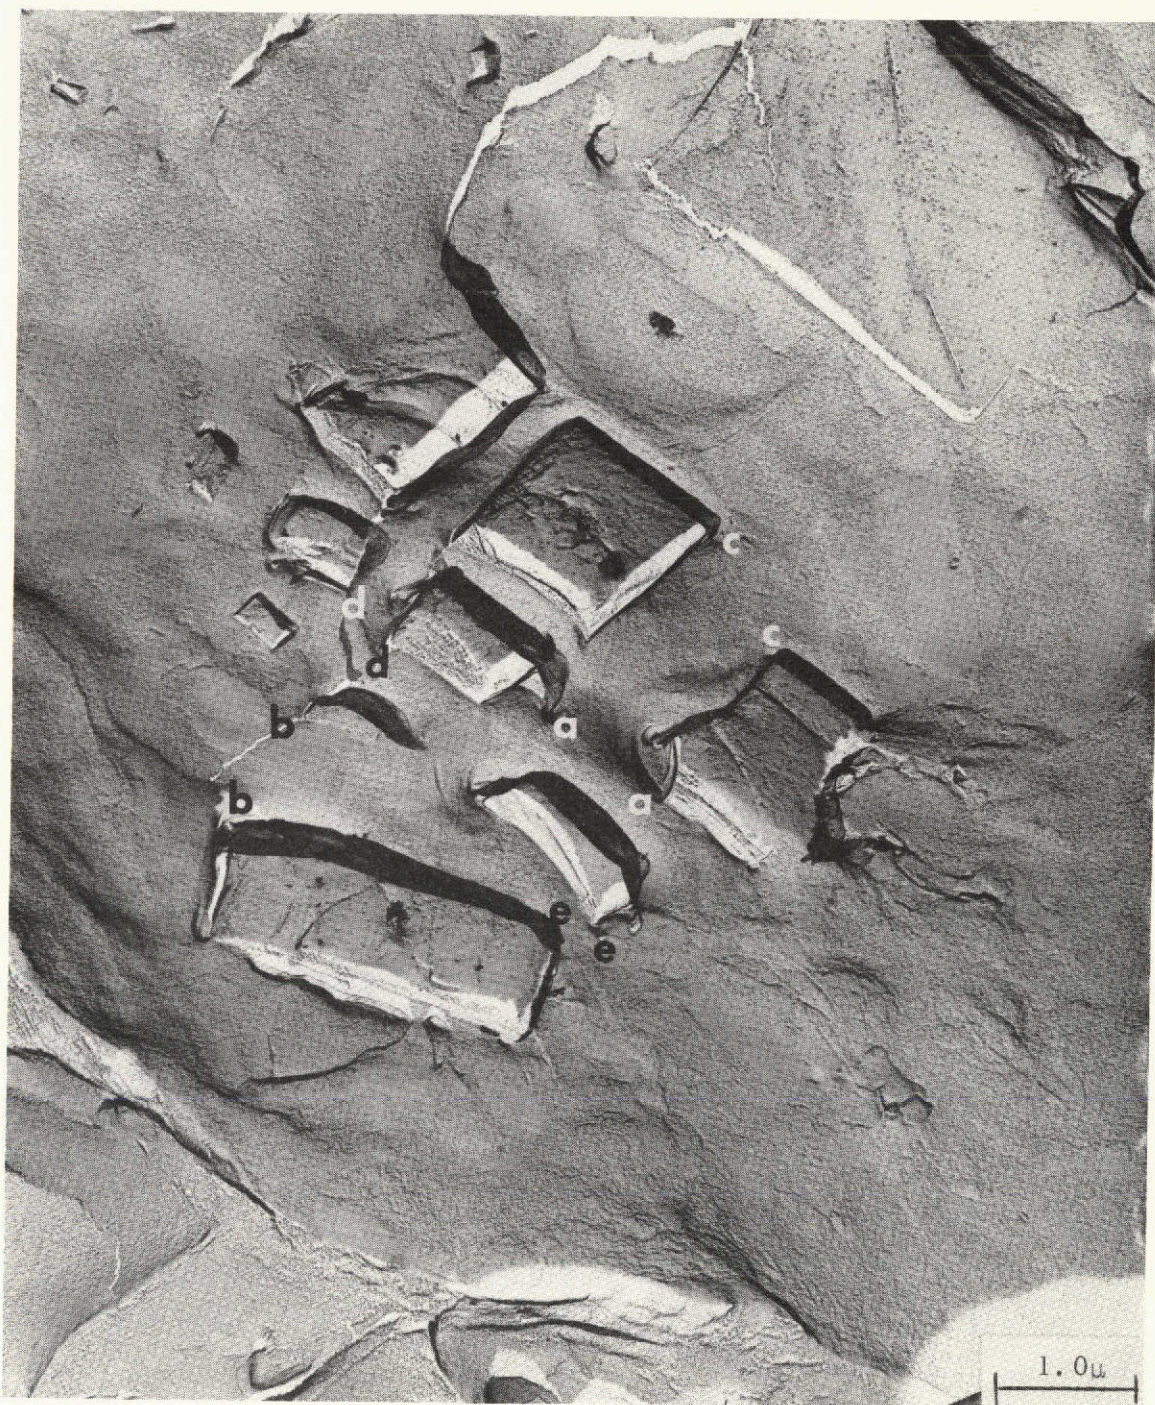
Figure 19 Fractured Carbo-Nitride on Notched Tension Fracture Surface of High-Purity 18 Ni Maraging Steel. (Like letters indicate matching points of shattered inclusion).

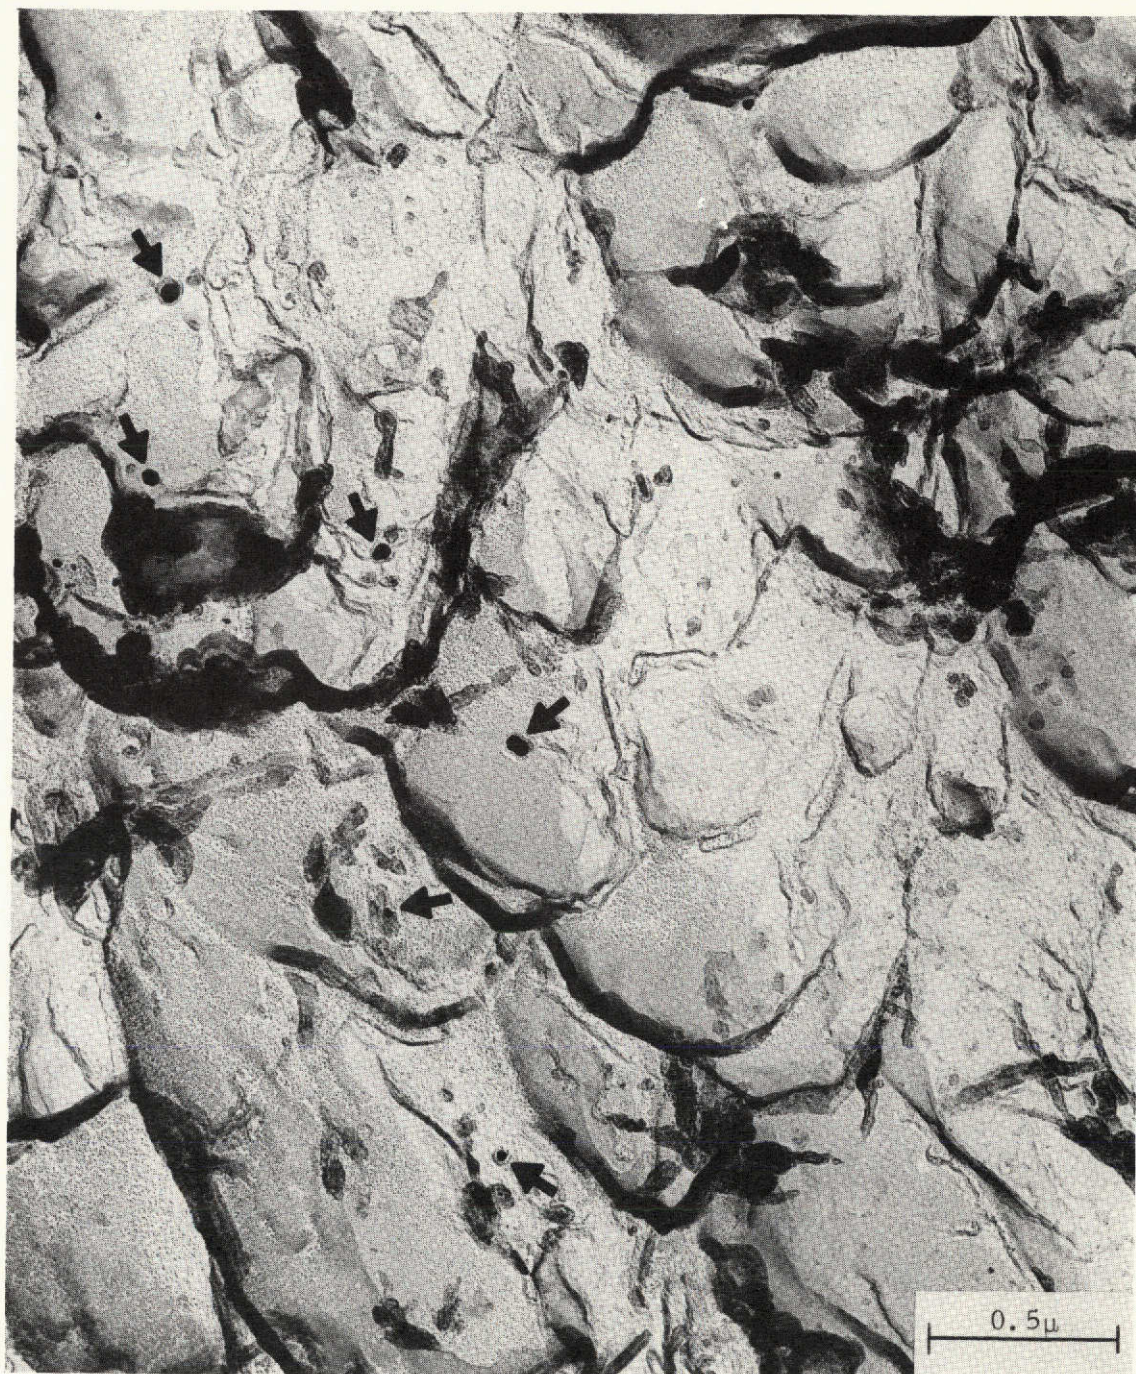
Figure 24 Extraction Replica from Smooth Tensile Fracture of Commercial AISI 4340 Steel.
(Arrows indicate extracted particles).

The procedure outlined above resulted in the extraction of many fine particles associated with the small dimples on the fracture surfaces of both commercial and high-purity AISI 4340 alloys. An example of an extraction replica taken from the commercial alloy is presented in Figure 24. Examples of extracted particles are indicated by the arrows on the fractograph. In order to identify the particles, electron diffraction techniques using the electron microscope were employed so that individual particles associated with the small dimples could be examined. Figure 25 presents individual extracted particles from both the commercial and high-purity fracture surfaces, together with the selected area electron diffraction patterns from the particles. The concentric ring patterns about the central spots of the diffraction patterns result from the fine grained polycrystalline platinum deposits used to shadow the replicas,

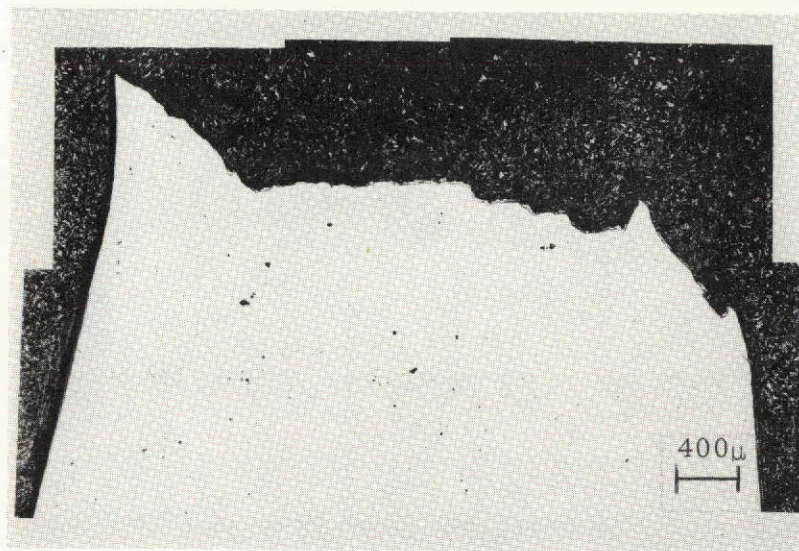
Figure 29 Midplanes of Fractured Tensile Specimens of Commercial AISI 4340 Steel.

As may be seen in the photomicrographs of the fractured tensile halves (Figures 29-32), the extent of the presence of large voids is greater for the commercial alloys than for the high-purity alloys. Also, the areas of voids are more restricted in the longitudinal direction in the notched specimens than in the smooth. This observation undoubtedly results from the fact that the presence of the notch concentrates the stress and strain in a narrow region centered on the notch. These observations are described quantitatively in Table VI where the exact sizes of the areas examined (hereafter referred to as critical areas) in each alloy are tabulated. It is also seen in Table VI that the size of the critical area of major void formation

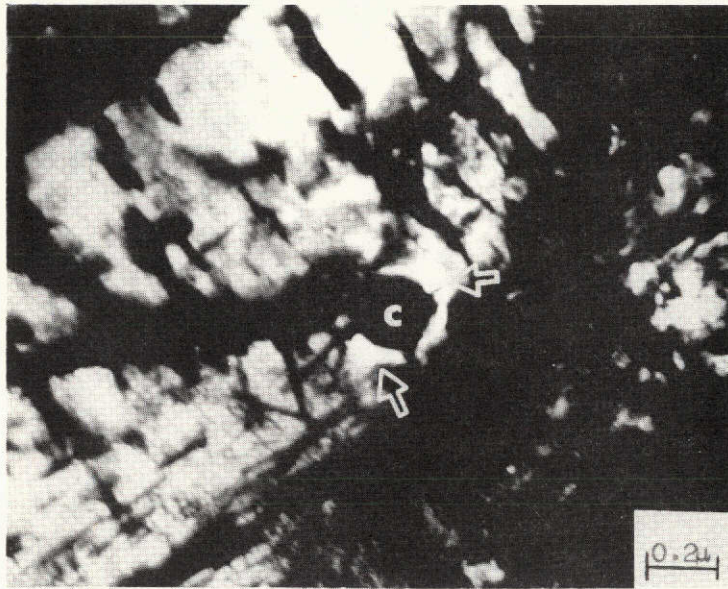
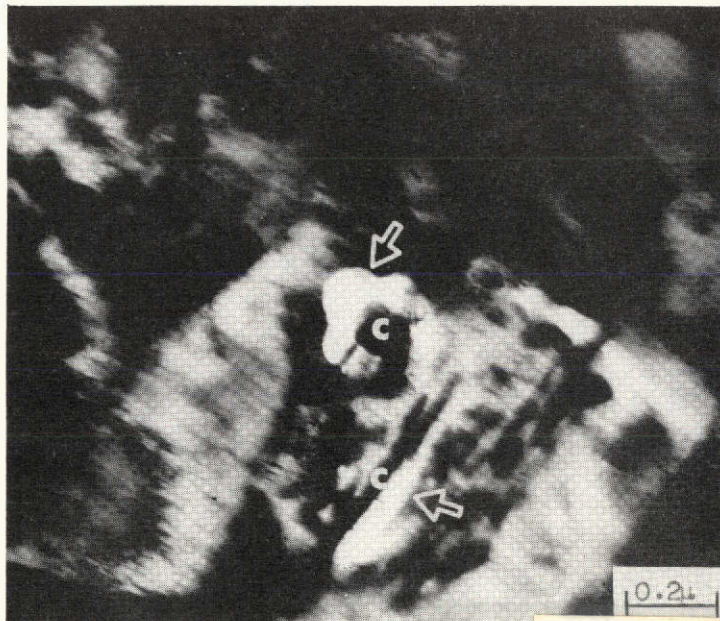
Figure 41 Void Initiation by Decohesion of Carbide-Matrix Interface in AISI 4340 Steel Strained Plastically (Arrows indicate voids and "C" indicates carbide)

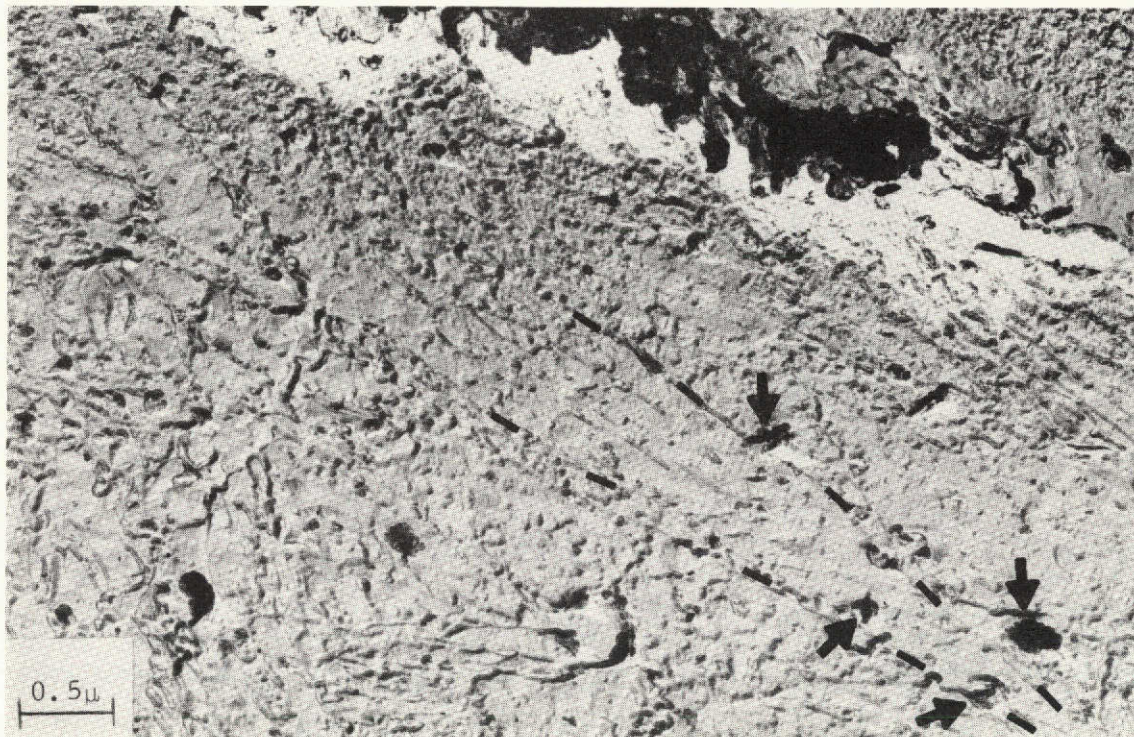
Figure 72 Voids Nucleated at Martensite Boundaries in Region of Severe Deformation Between Large Voids in AISI 4340 Steel (Arrows indicate voids and dashed lines indicates martensite lath boundary).
